Elevation Changes of the New SUBARU Ring Magnets

Sakuo MATSUI and Chao ZHANG

SPRING-8/JASRI

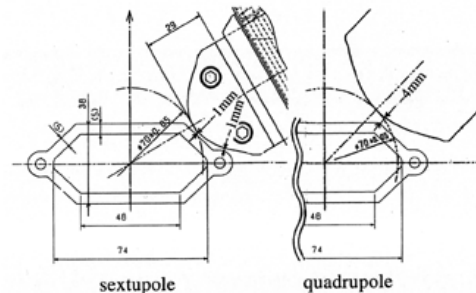
Fig. 3. Cross section of chamber and magnet poles.

divide. The upper half of the magnet was put on the lower half magnet and the chamber. Figure 3 shows the cross section of chamber and magnet poles. Moreover the chamber is enclosed with three heat insurance sheets. If the error of chamber production and alignment is large, the chamber contacts to magnet pole, and upper half-magnet shifts. The gap was checked by passing the nylon string between the chamber and magnet pole. Some magnets bit the chamber.

Since vacuum chamber was close to the magnet pole, many sextupole magnets inclined when chamber expanded. The tiltmeter on the fiducial plane showed the maximum tilt of 1mrad. The influence on the quadrupole magnet was smaller than that of sextupole. It is noted that the tilts did not seem to return to the initial ones after baking.

The alignment of vacuum chamber is also important.

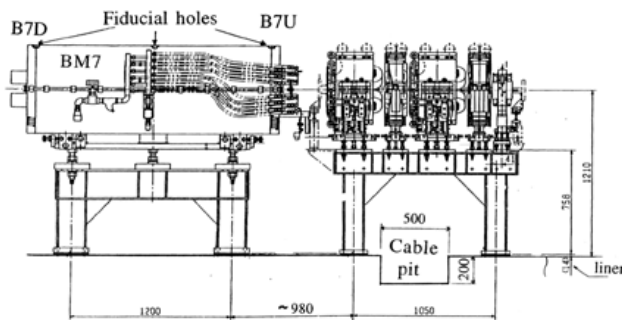
Fig. 5. Cross section of magnets and pit around BM7.

The levels of the bending magnets are shown in Fig. 7. This figure shows also pit position. The weight of bending magnet is 5 t. The weight of girder on which multipoles mounted is 1 to 1.5 t. It seems that the one leg of bending magnet near pit subsided.

The cable pit on the floor becomes one of the causes of unstableness. It is noted that the small liner under girder increases the pressure to the concrete.

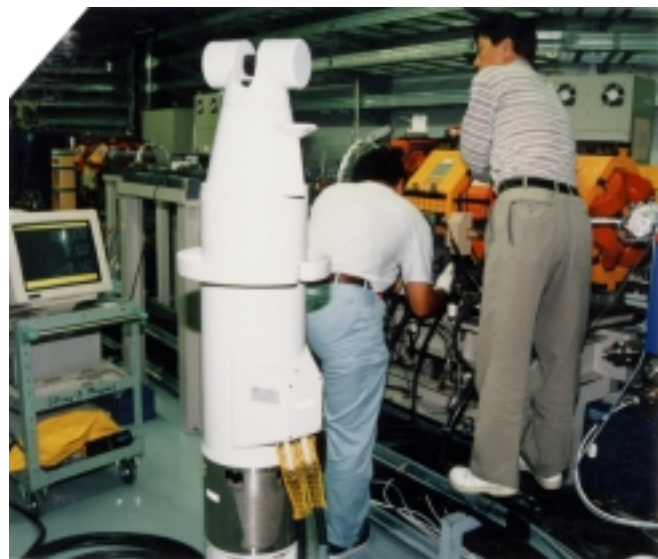
Fig. 9. Realignment of multipole magnets.

Moreover the changes of the levels and tilts suggest that the floor from BM5 to BM7 subsided. The magnet levels in Fig. 9 also exhibit this floor elevation change and the influence of pits.

The magnets on five girders enclosed with ellipse in Fig. 8 were realigned with the laser tracker. (Fig. 9)

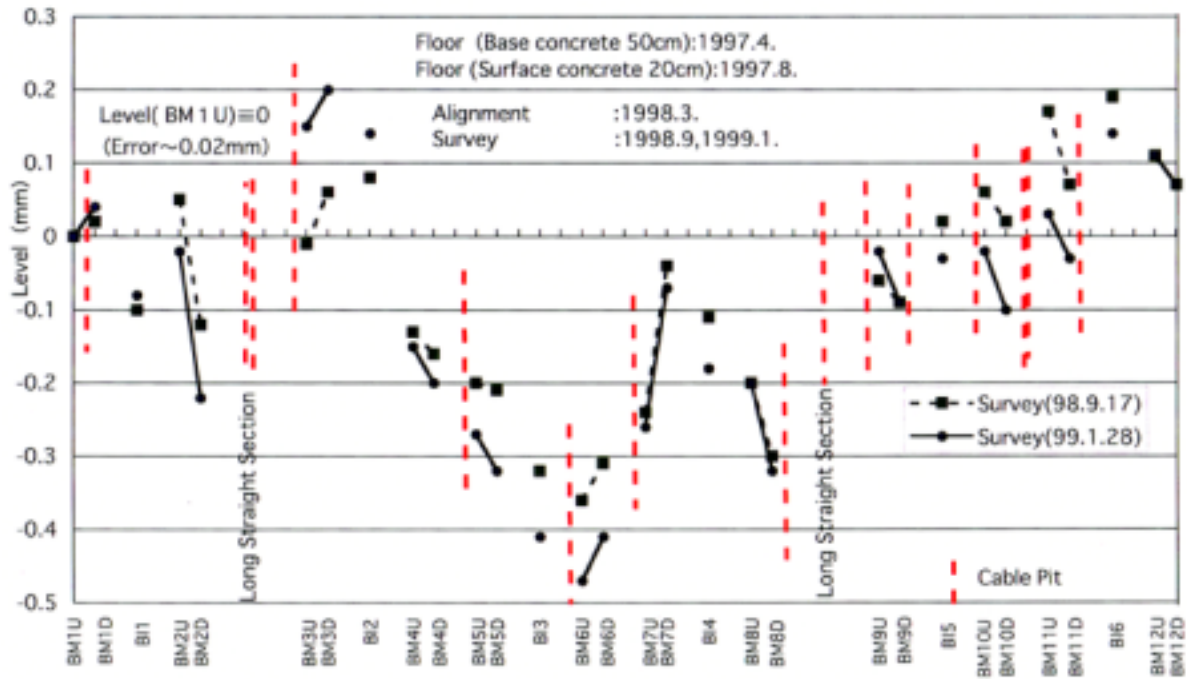
Fig. 7. Levels of bending magnets and pit position.

Four months later the alignment was carried out at March 1998. However the floor was not stable. In particularly, the elevation change of BM2 and BM7 were large. One side sank 0.2 mm down during six months. Multipole magnets were aligned at April 1998. The levels and displacements of multipole magnets were also surveyed with a laser tracker. (Fig. 8) The reference positions of this survey were on the bending magnets, which levels were already known. The horizontal large displacements are due to the survey error.

According to the subsidence of BM2 and BM7, it is supposed that the downstream girder of BM2 and the upstream girder of BM7 subsided. This is shown in Fig. 8.

It is quite necessary to survey the level at several months later after first alignment to check the change.
