BL43LXU (RIKEN Quantum NanoDynamics)

In FY2018, BL43LXU was dedicated mostly to user experiments ^[1]. However, some time was allocated to the installation and commissioning of new equipment (see below). The present report emphasizes both the changes and the problems at the beamline in an effort to provide an accurate record of progress and useful information to others

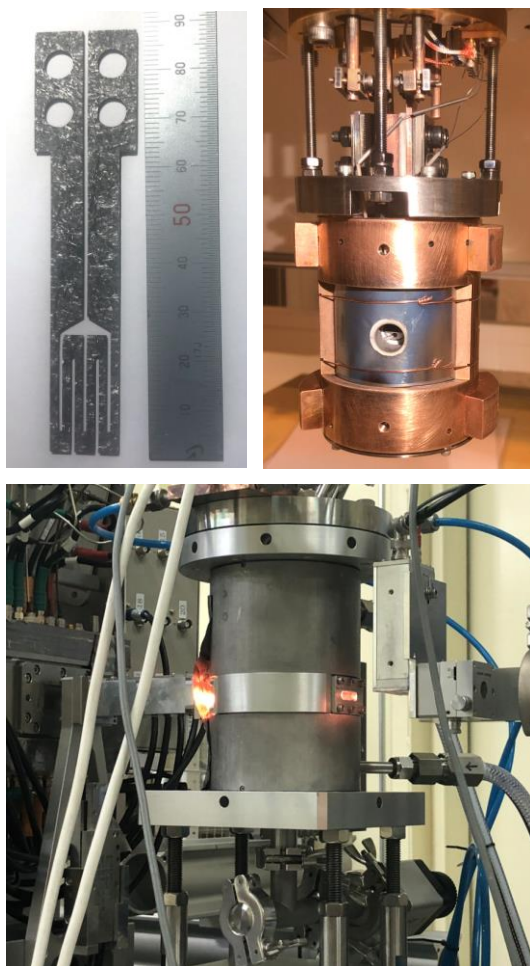
Fig. 1. High-temperature vacuum furnace. Upper left is one of the carbon composite heaters. Upper right is the sample unit before installation in the vacuum chamber. Lower panel shows the furnace in use at BL43LXU.

After repeated failures and a significant loss of beamtime because a user furnace was unable to sustain high temperatures, a new furnace was designed by A. Baron with help from M. Inui (Hiroshima University) and K. Matsuda (Kyoto University). The new furnace uses carbon composite heaters instead of tungsten or molybdenum wire heaters, fundamentally changing the entire internal structure and concept of the furnace. This new setup performed well. It stably held temperatures in excess of 1560 °C achieved in a vacuum over ~48 h period. Additionally, the heaters are suitable for repeated use (for four cycles per day).

This is a dramatic improvement over the previous furnace. The new furnace allows good data collection for liquid Fe and Co using both 0.8- and 1.3-meV resolutions. It is noteworthy that there was one occasion where the feedback failed and a Mo part (perhaps ~10 g of Mo) was melted and pooled on the lower ceramic insulator, indicating the temperature exceeded 2600 °C before the heaters failed. On another occasion, operations at 1900 °C were possible but only for a few hours before the heater failed. Thus, 1560 °C is thought to be reliable, but higher temperatures will require some work because all the heaters should be capable of achieving > 2500 °C.

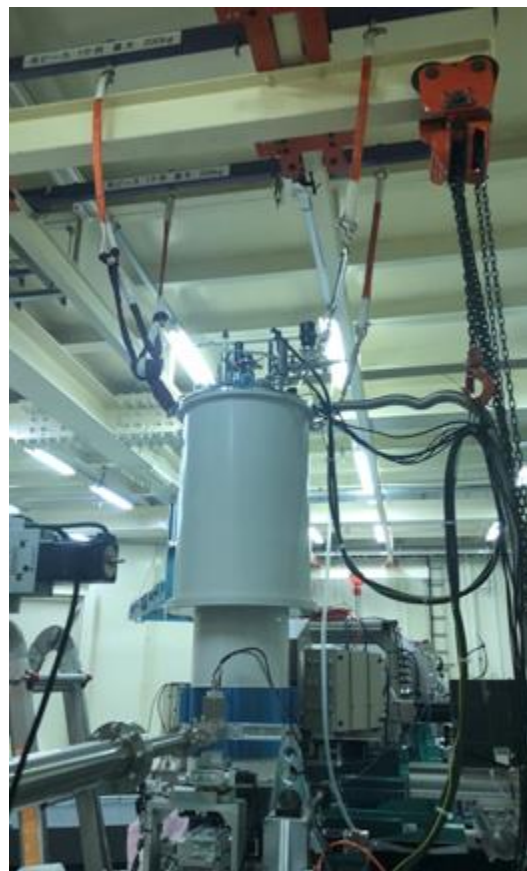
Fig. 2. 7-T cryomagnet installed on the high-resolution spectrometer.

We continued to commission the 7-T cryomagnet. This was originally a project of a post-doc who left

suddenly to take a permanent job in his home country. The initial tests with the beam at BL43LXU in FY2015 failed because Oxford Instruments had set the heat-switch current too conservatively (35 mA vs. a typical value of 72 mA), and they were not able to help until the experiment ended. We planned another experiment in June 2019 with D. Bessas, who was visiting from ESRF. During this time, the system controller failed (it had to be taken to Oxford Instruments in Tokyo to be fixed), a window developed a leak, and the Temperature control was slow, suggesting a blocked needle valve. These issues were addressed during the summer of 2019, and partly included re-designing the window with the intermittent leak.

The system performed well during testing (T was controlled from 2 K to 300 K, and $H < 1$ T) in September 2019. Many small auxiliary pieces were then ordered. More work is planned for December 2019. Our hope is that the Oxford system will not develop any new failure modes.
