# Elevation Changes of the Storage Ring Magnets

Sakuo MATSUI, Chao ZHANG, Kazuma NAKASHIMA, Hikaru KISHIMOTO, and Masayuki TANAKA  
 SPring-8, Kamigori, Ako-gun, Hyogo, 678-12, Japan

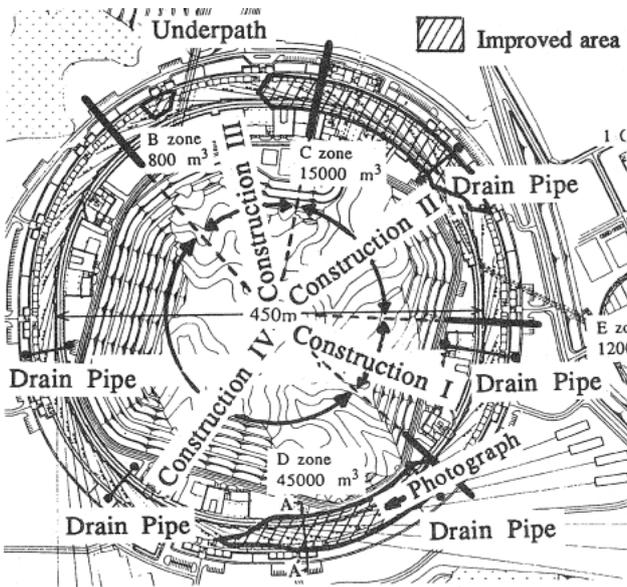
Fig.1. Area of foundation improvement and drain pipe etc.

Though the storage ring was constructed mostly on the hard rock, in some sections the ground was replaced by artificial hard rock (Fig.1). The total volume of foundation improvement including that for the linac and synchrotron areas was 70000 m<sup>3</sup>. Figure 2 shows the cross sectional view. The schedules for the tunnel construction and magnet installation are summarized in Table1. The tunnel was constructed in four phases. After the tunnel construction, the baseplates were made into the floor. Then girders were set on these baseplates.

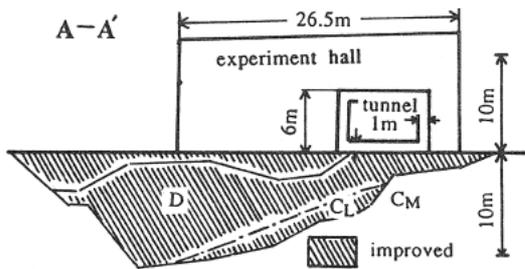
Fig.2. Cross sectional view of the improvement.

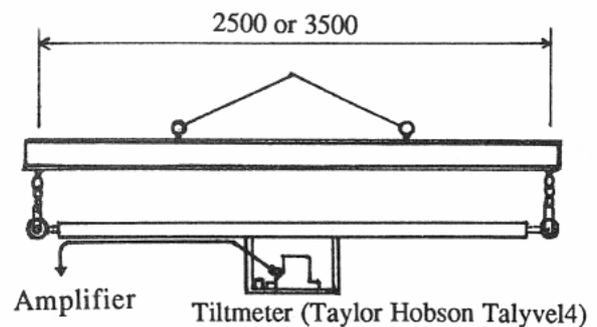
A Wild N3 level was usually used for the level survey. The target pattern is on the glass plate in the spherical ball. (right photo-graph). Since this method strained the eyes, new instruments were developed. The level difference was determined by measuring the tilt (Fig.3) (Tilt bar method)

Fig.3. Tilt bar method.

[1]. Although the stability was not so good, its accuracy was considered to be better than that of N3.

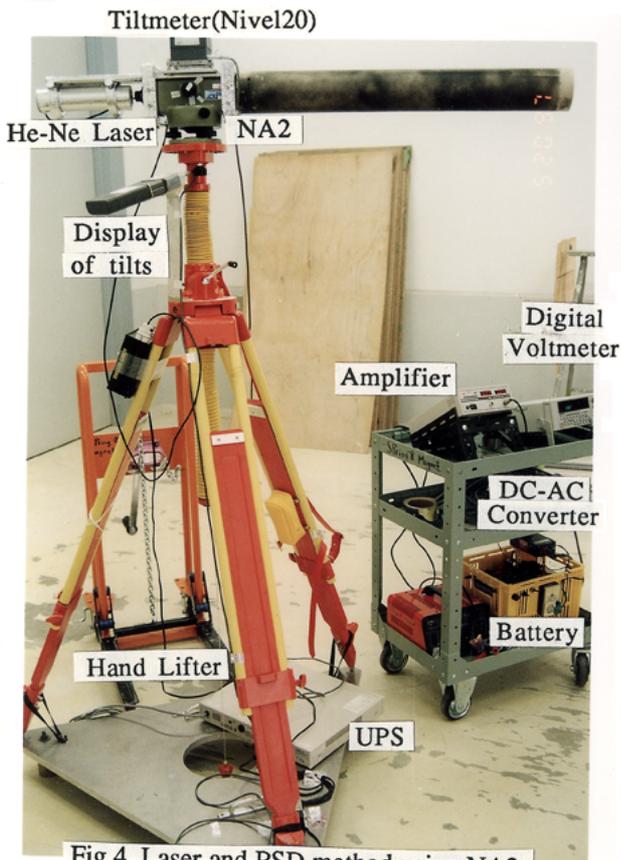
Another method using autolevel NA2 and He-Ne laser is shown in Fig.4. The detector is PSD (Position sensitive device) (Fig.5) (Laser-PSD method). Since the output of this method always fluctuates, it is averaged out using a digital voltmeter. As small a difference as 10  $\mu$ m can be measured by this method as long as the distance is less than several meters. The pendulum compensator of NA2 was able to decrease the tilt of laser light approximately 20 times.

Fig.4. Laser and PSD method using NA2.

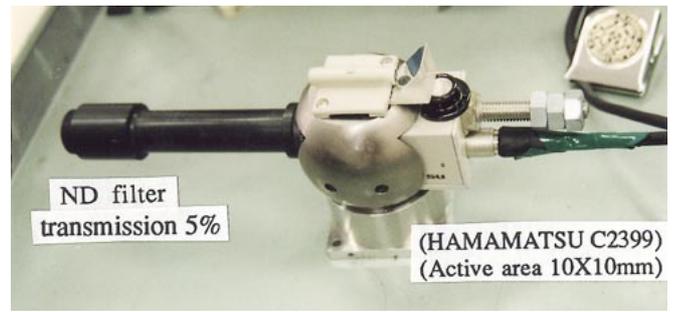
Fig.5. PSD Target.

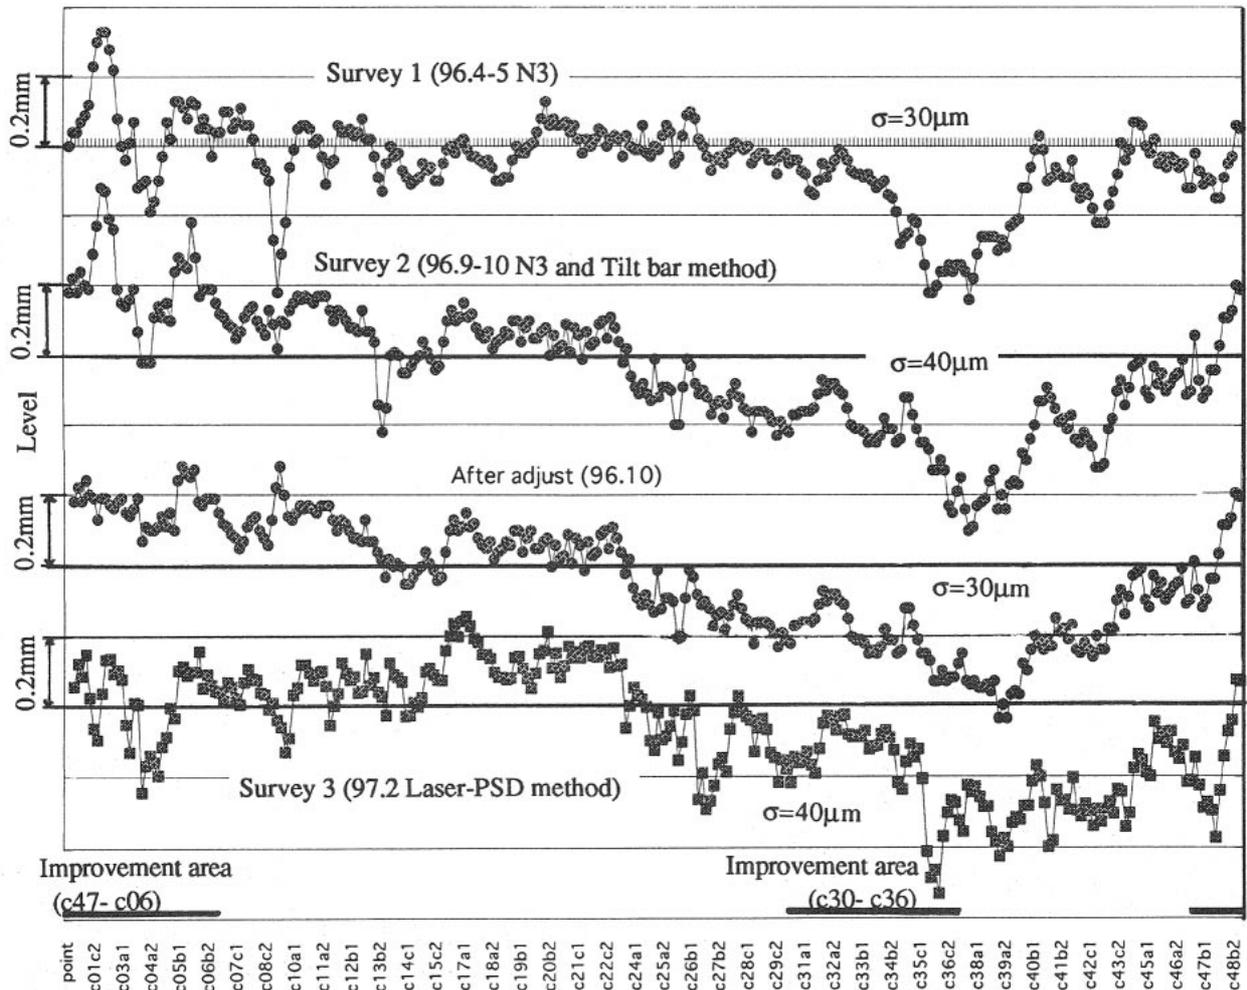
Magnet levels were surveyed three times (Fig.6). The level difference between two points that are far apart is not reliable. The standard deviation of the relative level between the next girder are also shown.

Fig.6. Level survey results

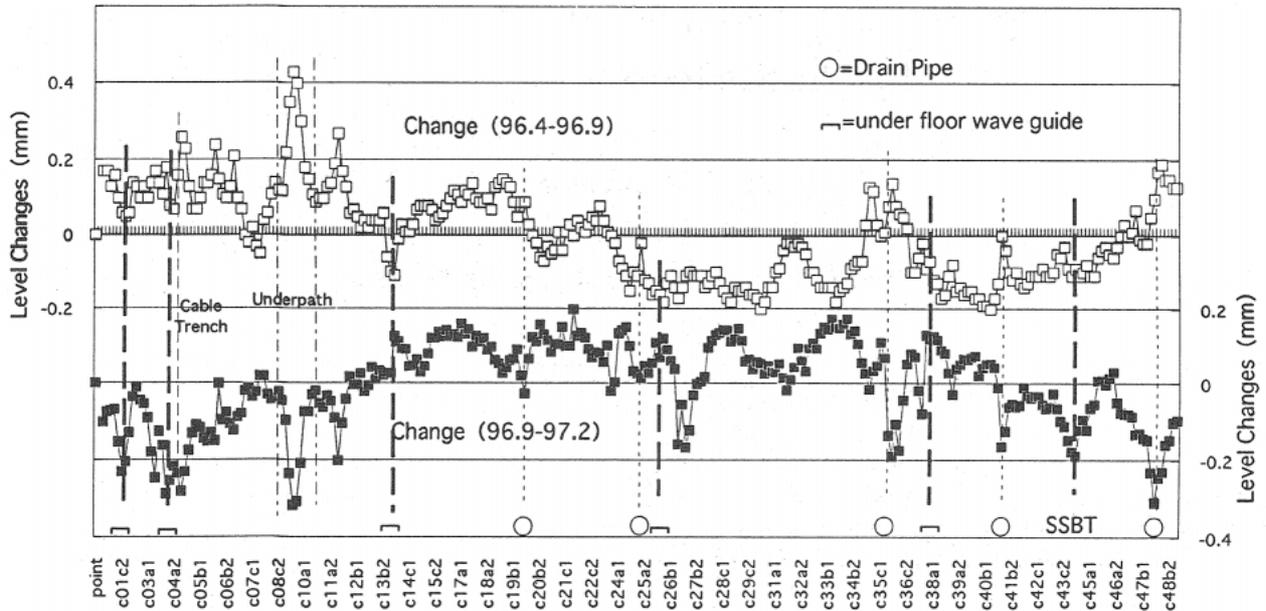
Fig.7. Level changes between two surveys.

After the Survey2, twenty girders were adjusted. Figure 7 shows the changes between the two surveys.

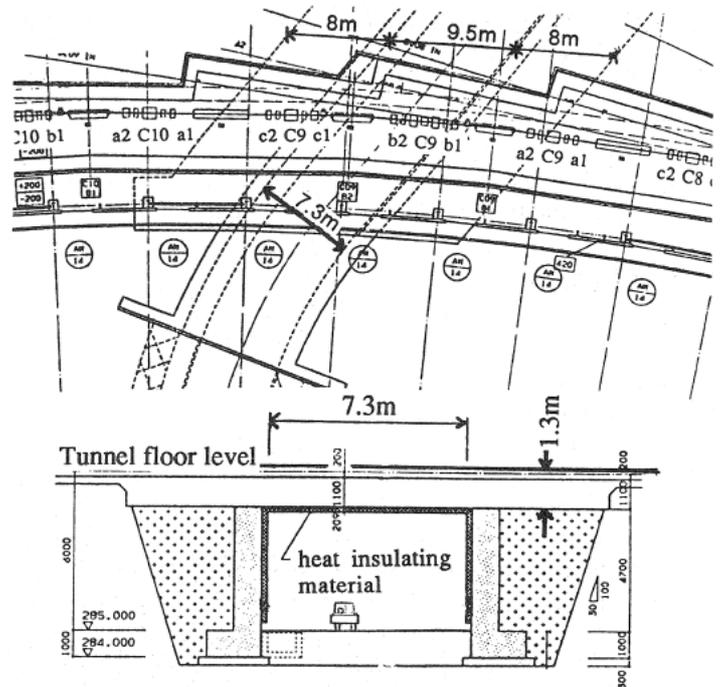
The elevation at the 10 m long underpath for vehicle rose up to a maximum of 0.4 mm during the summer and decreased by 0.4 mm during the winter because of ambient temperature changes. The cross section is shown in Fig.8.

Fig.8. Underpath for vehicle.

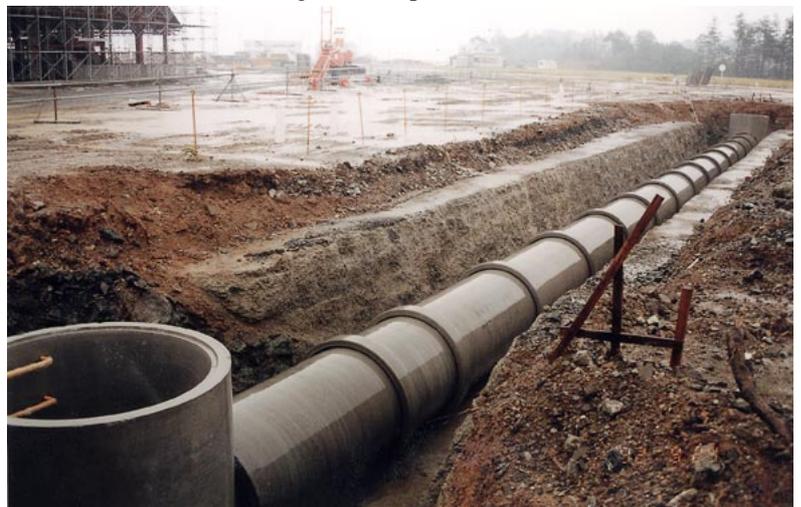
The floor levels over underground drain pipes of 0.9m diameter at five locations changed from  $\pm 0.1$  to  $\pm 0.2$  mm in the same way. Since both ends of this pipe were opened in the air(Fig.9), the floor over the pipe section was warmed and cooled.
