# Development of Long-Life Next-Generation Li-Ion Batteries

Clarification of the causes of performance deterioration of Li-ion batteries

Beamline used at SPring-8: Sunbeam BM (BL16B2)

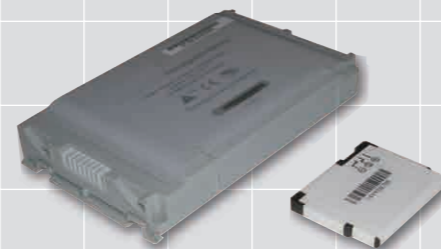
## Principle of Li-ion battery

A Li-ion battery comprises a cathode, an anode, an electrolyte, a separator, and other elements. The battery performance is determined by the cathode material, and  $\text{LiCoO}_2$  is currently widely used. Graphite (C) is used for the anode and lithium salt for the electrolyte. During charging, the  $\text{Li}^+$  in the cathode dissolve in the electrolyte and penetrate into the graphite structure of the anode. The opposite reaction occurs during discharging.

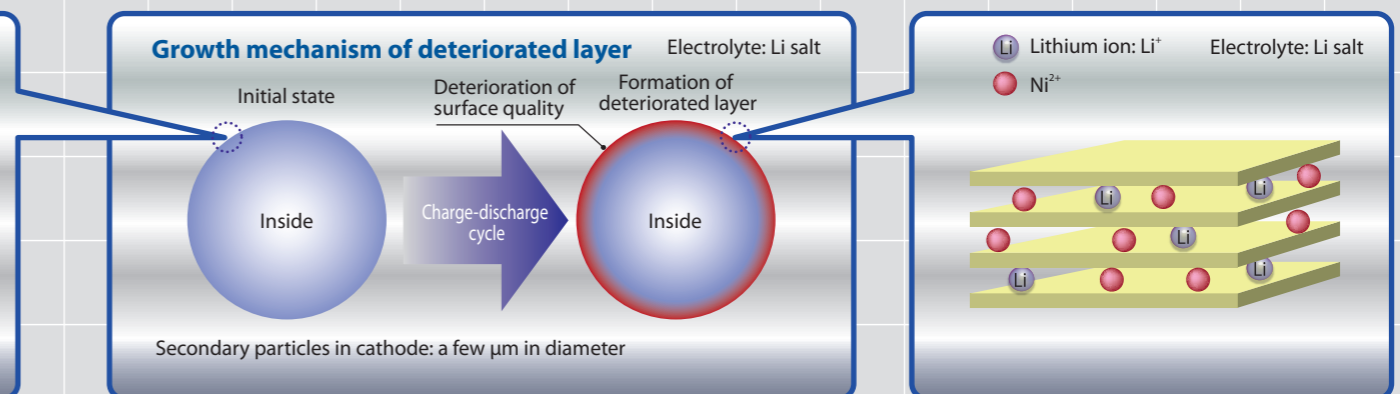
## Mechanism underlying deterioration of battery performance

1) Growth of deteriorated layer  
The actual cathode comprises cathode particles of a few  $\mu\text{m}$  diameter (secondary particles) surrounded by an electrolyte, each of which is an aggregate of a number of single-crystal particles (primary particles). It becomes increasingly difficult for the surface of these secondary particles to pass  $\text{Li}^+$  upon repeated charging and discharging.

2) Deteriorated layer blocking path of  $\text{Li}^+$   
From the atomic-level observation, it was found that the path of  $\text{Li}^+$  is blocked by  $\text{Ni}^{2+}$  that replace some of the  $\text{Li}^+$  upon repeated charging and discharging.

The SPring-8 high-brilliance X-ray enables us to directly observe the states of cathode particles. As a result of observing a battery that was repeatedly charged and discharged, it was clarified that a deteriorated layer with decreasing transmission of  $\text{Li}^+$  was grown on the surface of the cathode particles and that  $\text{Ni}^{2+}$  block the path of  $\text{Li}^+$ . From the observation of batteries with different electrode compositions, we found a composition at which the formation of a deteriorated layer can be suppressed. Thus, the life of batteries was successfully prolonged.
