# Displacement and Deformation of Vacuum System Installed in the SPring-8 Storage Ring

Mitsuhiro MASAKI, Yukiko TANIUCHI, Michio MAENO, Shigeki SASAKI
Hiroshi SAEKI, Kowashi WATANABE and Haruo OHKUMA

SPring-8, Kamigori, Ako-gun, Hyogo 678-12, Japan

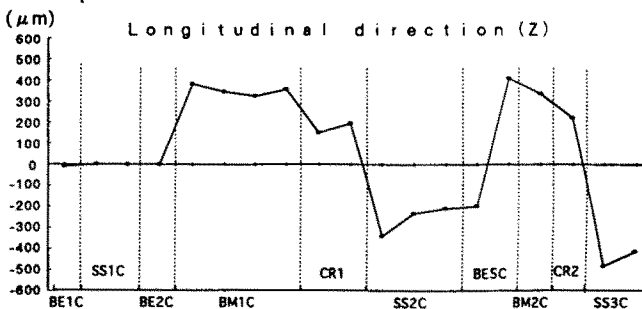
The vacuum system consists of three straight section chambers (SS1C, SS2C and SS3C), two bending magnet chambers (BM1C and BM2C) and other components. Figure 1 shows the displacements to Z axis direction. SS2C, SS3C, BM1C and BM2C with the large radius bellows are displaced about 400μm toward crotch chambers. This results are

Fig.1 The displacements of the vacuum chamber the longitudinal direction (Z) due to evacuation.

improved remarkably in comparison with that of the pilot one-unit-cell[1]. It is expected that the two crotch chambers do not move in any direction due to evacuation, because they are supported rigidly. The measurement, however, indicates unexpectedly that

they move about 200μm. This seems to be because their supports are bent by the force of evacuation.

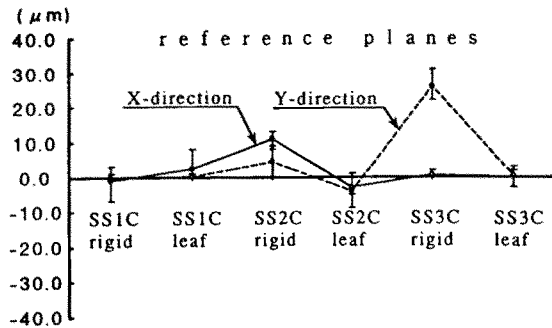
Figure 2 shows the displacements of BPM reference planes. X and Y direction's results are less

Fig.2 The displacements of the BPM reference planes due to evacuation. The solid line and the dashed line show X-direction's and Y-direction's results, respectively.

than 10μm and 30μm, respectively. There is no essential deference between the rigid support sections and leaf spring sections. The SSC in the upstream is fixed to a magnet girder (rigid support section) and the SSC in the downstream is supported by a leaf-spring device, making it possible to accommodate expansion to the Z direction (leaf spring section).

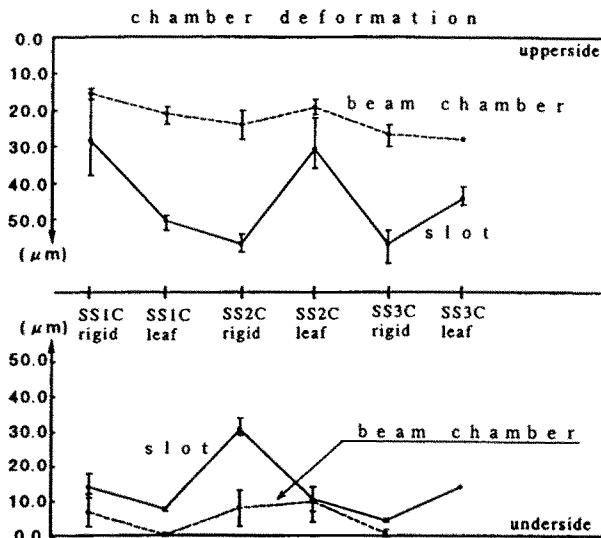
Figure 3 shows the chamber deformations at the BPM sections for the reference blocks.

Fig.3 The deformations of BPM sections for the reference blocks are shown. The solid lines and dashed lines show the deformations of the slots and beam chambers, respectively.

The variations of distance between uppersides of the reference block and vacuum chamber were measured by using depth gauges. The measurements for undersides were performed in the same way. The results show that the upperside's deformation is about twice as large as the underside's one. This means that the chamber was deformed asymmetrically and the electrical center of BPM shifts. The shift estimated geometrically is 10~20μm.

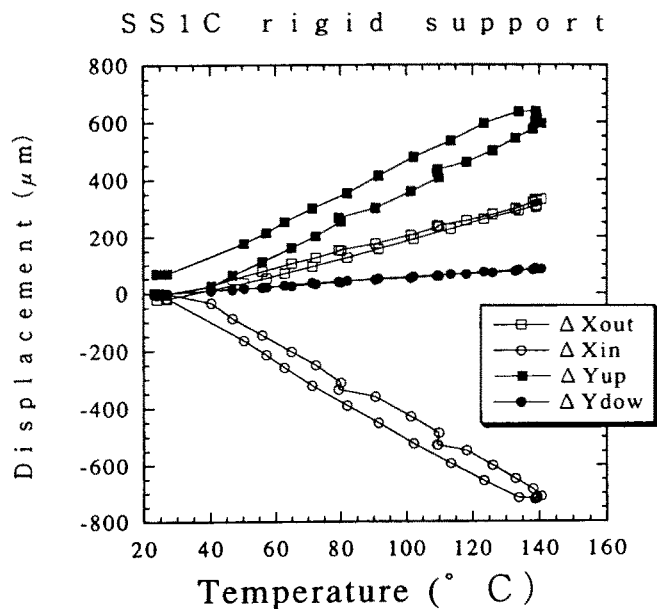
SS1C rigid support

Figure 4 shows displacements at each side of the BPM reference block. These curves are dominated by

Fig. 4 The temperature dependence of the displacements at each side of the BPM reference block.

the thermal expansion of the reference block itself except underside (Ydow) which is displaced for the positive direction of Y axis. The reinforced blocks in BPM sections which suppress the deformation due to evacuation have the same tendency as well. The position of reference planes, after bakeout, is reproduced within the values shown in Table 1.
