Elevation Changes of the New SUBARU Ring Magnets

Sakuo MATSUI and Chao ZHANG

SPRING-8/JASRI

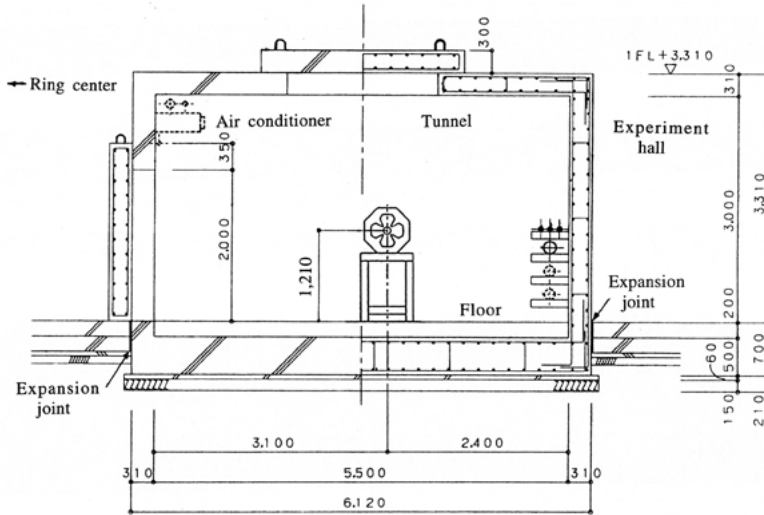
Fig. 1. The cross sectional view of the beam tunnel.

The New SUBARU storage ring is located in the SPRING-8 site. This ring is on the Sayo gravel bed. It consists of conglomerate clay layer. The cross section of the beam tunnel is shown in Fig. 1. The thickness of the floor concrete is 70 cm. However the final concrete (20 cm) was not filled at the cable pit.

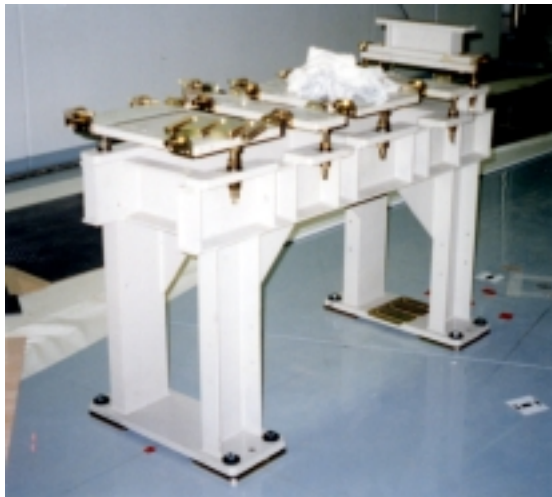
Fig. 2. Normal girder on the floor.

This ring has 6 cells with a circumference of 119 m. One cell has 2 bending magnets (BM) and one invert bending magnet (BI) at the middle and multipole magnets on four girders. The length of one girder is 1~2 m. These girders have no base plates. (Fig. 2)

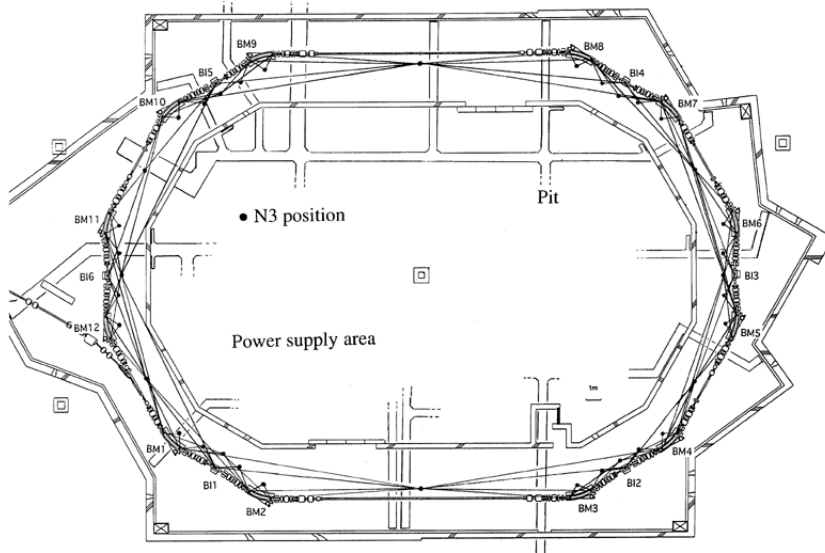
Fig. 4. Network for the level survey.

The levels of bending magnets were surveyed at September 1998 (half year later after first alignment) and January 1999. Fig. 4 shows the network using a Wild N3. The levels were calculated by least square method. This figure also shows many pits for cable and water duct. Figure 5 shows the example of cross section of bending, multipole magnets and pit, and Fig. 6 the pit around BM10.
