C99A24XU-033N BL24XU

## Observation of Crack Initiation in Structural Materials by Refraction Contrast X-ray Imaging

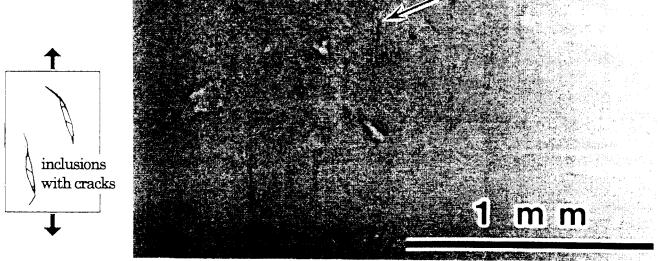
Fig.1 Refraction X-ray image of nonmetallic inclusions of tensiled steel with 0.5 mm in thickness taken at SPring-8. It indicates the formation of micro-cracks between inclusions and matrix.

Fig.1 shows the refraction contrast X-ray image of the steel sample after tensile test. It is obvious that inclusions, which was confirmed to be MnS nonmetallic compounds by EPMA, are seen in steel. The dark contrast of the edge parts of inclusion is thought to confirm refraction image, and to indicate the formation of micro-cracks between the inclusion and matrix. The fact that the such images of nonmetallic inclusion were not obtained in non-tensiled sample is also thought to support above-mentioned conclusion.
