Three-dimensional Topography using an X-ray Microbeam and Novel Slit Technique

Ryohei Tanuma* and Tae Tamori

Fuji Electric Advanced Technology Co., Ltd.

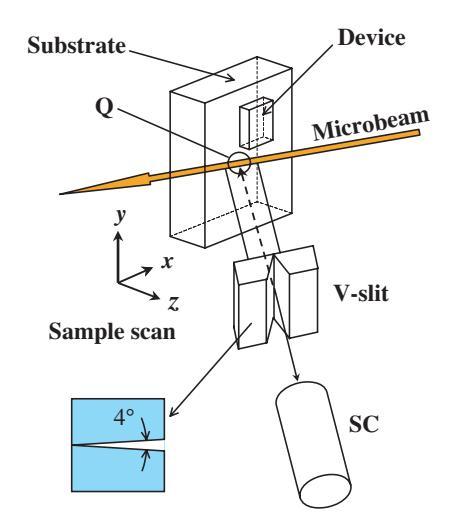
Fig. 1. Experimental setup. An X-ray microbeam penetrates a sample and a diffraction beam impinges on the V-slit, through which a thin beam passes to reach a scintillation counter (SC). Scanning the sample produces 3D topography. The V-slit is a metal contact made of stainless steel with polished slanted edges.

Experiments were conducted at the undulator beamline BL24XU. A monochromatic X-ray beam (E = 15 keV) was focused on a sample using a bent cylindrical mirror. The half widths (at 1/e of the maximum) of the focused beam were 1.16 μ m and 1.04 µm in the horizontal and vertical directions, respectively. We used a special slit with a V-shaped crevice (V-slit) for microbeam X-ray diffraction (Fig. 1). The V-slit is a metal contact made of stainless steel with polished slanted edges and an opening angle of 4°, that has a sharp-pointed exponential transmission curve [1]. The diffraction beam impinges on the V-slit, through which a thin beam passes to reach a scintillation counter (SC). We can thus observe a small region Q, where the incident beam crosses the extended line (broken arrow) of the beam passing

through the slit, and scanning the sample position provides 3D topography. Although the image obtained involves blurring caused by the tailed transmission curve of the slit, deconvolution can effectively restore the image [1].

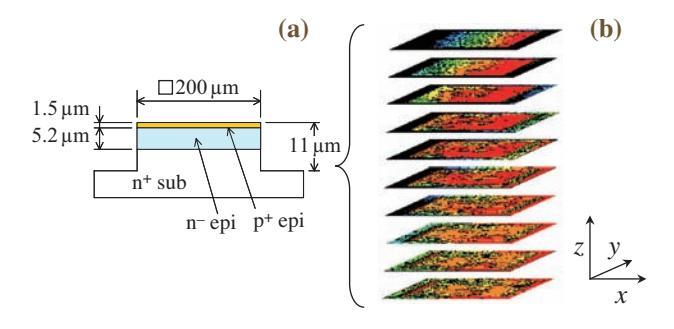
Fig. 2. Cross-sectional view of the sample SiC diode (a) and its slice topographs (b). The diode was fabricated on an 8°-off-cut (0001) 4H-SiC wafer (a). The slice topographs were obtained by performing a z (depth) scan and a 2D scan at each z position (b).

The sample examined is a 200 \times 200 μm^2 p-n diode fabricated on an 8°-off-cut (0001) 4H-SiC wafer (Fig. 2(a)). As shown in Fig. 2(b), slice topographs (SiC 0 0 20 reflection) were obtained by performing a z (depth) scan and an x-y scan at each z position. Figure 3(a) shows a slice image (log scale), in which we observed three screw dislocations (SD1, SD2, and SD3). To examine the depth distribution of the SDs, x-z-section topographs along the SDs were reconstructed (Figs. 3(b), 3(c), and 3(d)). The broken lines indicate the interface between the epilayer and the substrate (epi/sub interface). Since the z scale is six times greater than the x scale, the slight slant of the sample is exaggerated. These figures clearly indicate that the SD lines penetrate the epi/sub interface.

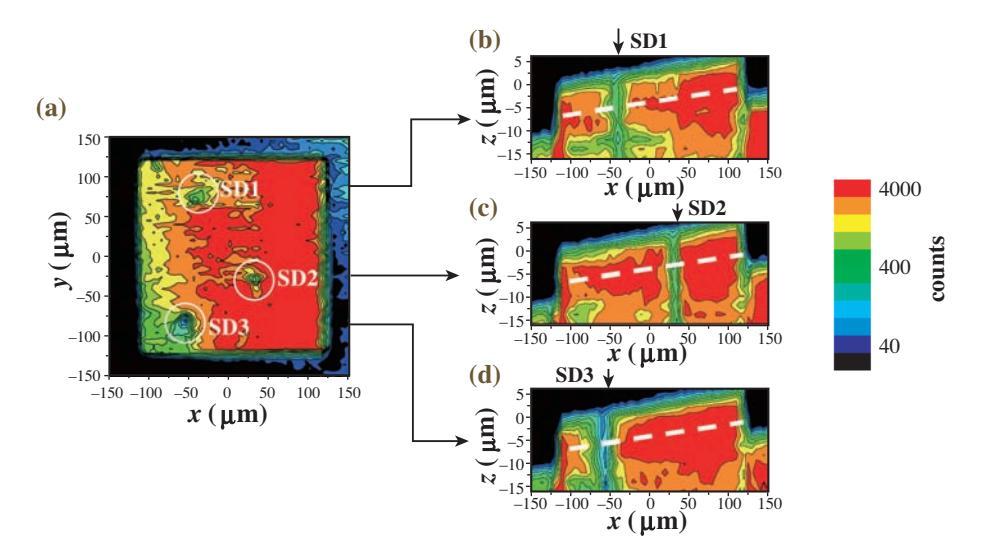
Fig. 3. Analysis of screw dislocations in a SiC diode. The *x*-*y* slice topograph (**a**) and *x*-*z* section topographs (**b**)-(**d**) were obtained from a 3D scan over the device region. The topographs show three screw dislocations (SD1, SD2, and SD3) that penetrate the epi/sub interface (broken lines).

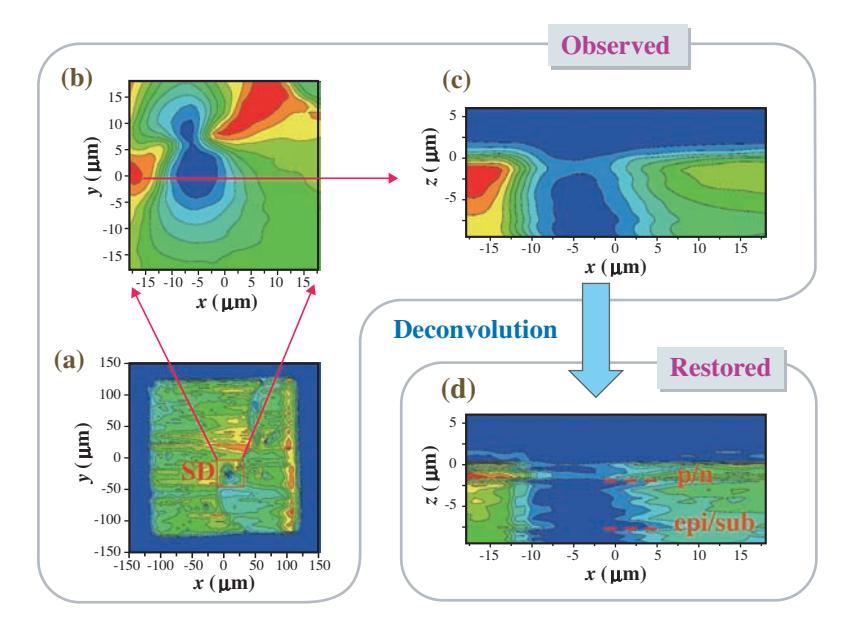
Fig. 4. High-resolution defect analysis of a SiC diode. The slice topograph shows a screw dislocation (SD) (a). An *x*-*y*-*z* fine scan around the SD was performed to obtain the *x*-*y* and *x*-*z* topographs (b)(c). Deconvolution provides the restored image, in which the two boundaries of the dislocation as well as the wafer surface become clear (d). These boundaries are in good agreement with the p/n junction and epi/sub interface (broken lines).

Figure 4(a) shows a slice topograph (linear scale) of a similar diode with a SiC 0 0 16 reflection, where we observe an SD located on an upwardly winding grain boundary. We performed an *x-y-z* scan in a small region including this SD and obtained the *x-y* and *x-z* topographs shown in Figs. 4(b) and 4(c), respectively. For the *x-z* cross-sectional images, we performed a deconvolution [1] to restore the image. Note that the two boundaries as well as the wafer surface become clear in the restored image Fig. 4(d). These boundaries are in good agreement with the p/n junction and epi/sub interface (broken lines). The image restoration can improve the spatial resolution from about 2 μ m to 0.5 μ m or less.
